Evaluation of magnetic resonance imaging issues of titanium and stainless steel brackets

KEYWORDS: MRI issues, artefact, magnetic field interaction, heating, orthodontic bracket

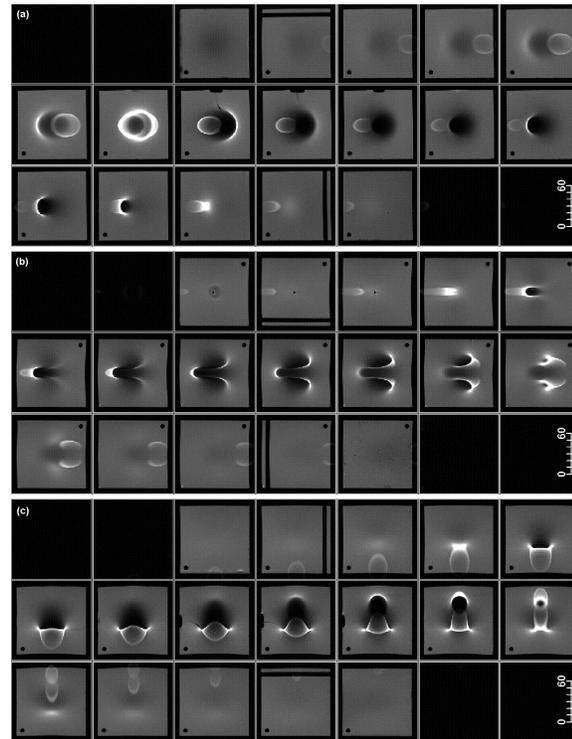
Fig. 1 SE artefacts with a single Gemini bracket the bracket size as in Table 1. Acquisition parameters: SE, 21 slices, thickness 3 mm, gaps between slices 3 mm, FOV 120 mm × 120 mm, matrix 256 mm × 256 mm, TR = 3000 ms, TE = 15 ms, refocusing pulse flip angle 180°, bandwidth 125 Hz/pixel. (a) Transverse slices with LR readout. For the other gradient assignment, the artefacts were found nearly identical with axes exchanged. (b) Coronal slices with LR readout. The same artefact shapes appeared in sagittal slices with AP readout. (c) Sagittal slices with IS readout. The same artefacts were found in coronal slices with IS readout.

For each single bracket, the maximal distance between the bracket boundary and the fringe of the artefact, as well as the maximal artefact area are listed in Table 4. In MRI imaging using the GE sequence, which is more prone to metal artefacts than the SE sequence, the linear size (*d*) of the distortion caused by SS bracket was by about an order of magnitude larger than that found with the Ti bracket (in sagittal images > 50 mm versus 4.9 mm, in coronal images > 50 mm versus 4.7 mm and in transversal images > 50 mm versus 4.8 mm). Furthermore, the artefacts caused by a single SS bracket often extended over the whole observed volume, i.e., over all slices and the whole ROI (Figs. 1, 2), while distortions caused by the titanium bracket were just local (Figs. 3, 4). The dependence of artefact size on echo time in GE images was

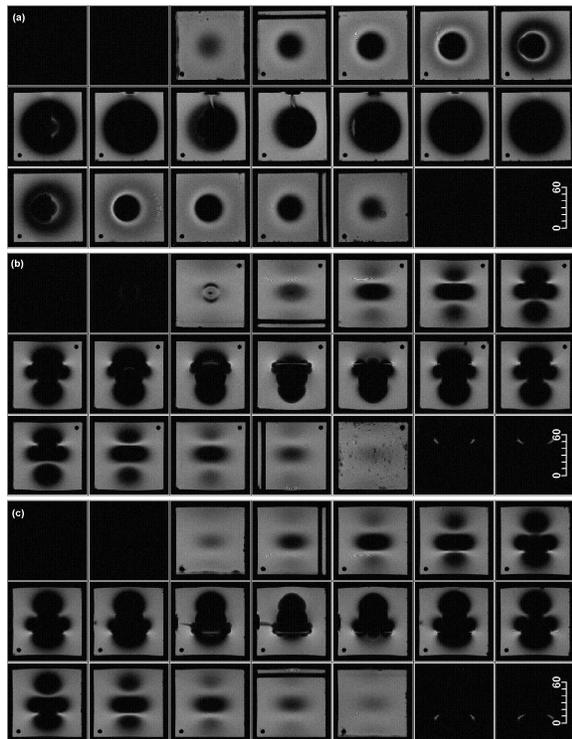
Fig. 2 GE artefacts with a single Gemini bracket the bracket size as in Table 1. Acquisition parameters: GE, 21 slices, thickness 3 mm, gaps between slices 3 mm, FOV 120 mm × 120 mm, matrix 256 mm × 256 mm, TR = 200 ms, TE = 10 ms, flip angle 35°, bandwidth 125 Hz/pixel. (a) Transverse slices with LR readout. (b) Coronal slices with IS readout. (c) Sagittal slices with IS readout. No effect of gradient assignment change was observed.

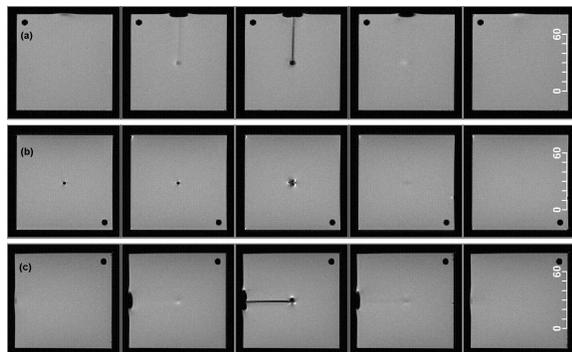
Fig. 3 SE artefacts with a single equilibrium ti bracket. The same measurement parameters as in Fig. 1. (a) Transverse slices. (b) Coronal slices. (c) Sagittal slices. Change of gradient assignment had no effect.

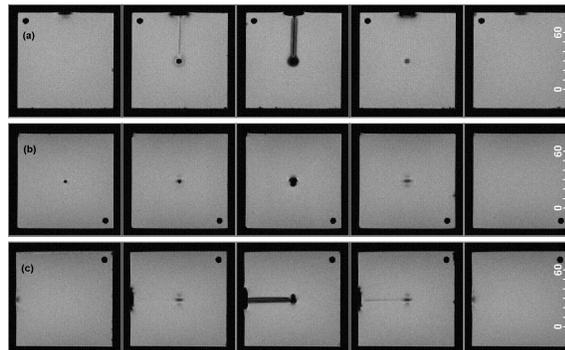
Fig. 4 GE artefacts with a single equilibrium ti bracket. The same measurement parameters as in Fig. 2. (a) Transverse slices. (b) Coronal slices. (c) Sagittal slices. Change of gradient assignment had no effect.

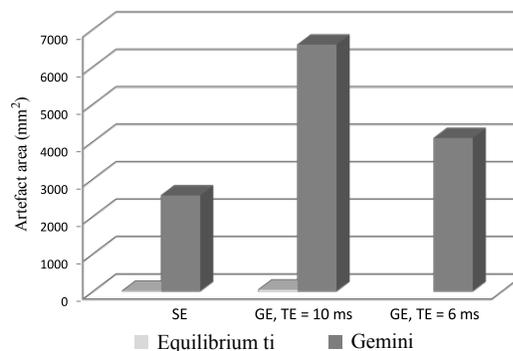
Fig. 5 Comparison of artefact areas in sagittal images for a single equilibrium ti and Gemini bracket. The column height in the graph represented the artefact area found in the sagittal images for both SE and GE images. As the artefact of GE image (TE = 10 ms) for Gemini bracket extended outside of the phantom volume, the artefact area outside of the box was estimated and overall artefact area evaluated to 6600 mm². GE images for TE = 6 ms were not acquired for equilibrium ti.

also observed (Fig. 5). The whole set of the SS brackets mounted on a jaw model precluded MR measurement by rendering the system incapable of adjusting the resonance frequency. Artefacts caused by titanium brackets mounted on a jaw model were considered diagnostically acceptable according to visual scale (Table 3), because the distortions were just local. They are displayed in Fig. 6.

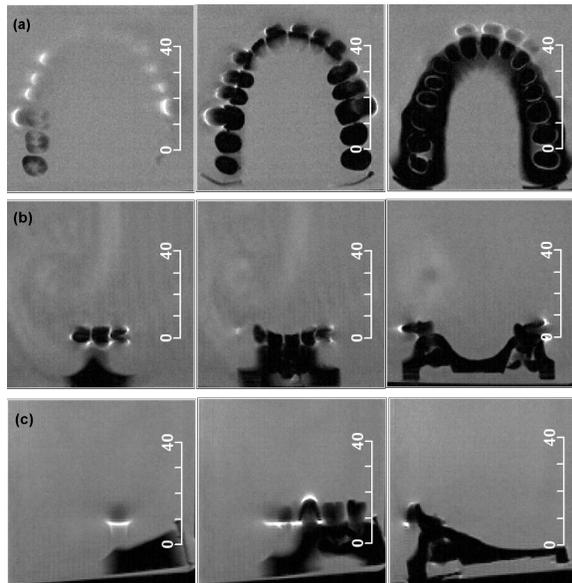
Fig. 6 SE artefacts with equilibrium ti bracket sets mounted on a jaw model. (a) Transverse slices, LR readout, IS position 42 mm, 48 mm, and 54 mm from the central slice. (b) Coronal slices, LR readout, AP position 24 mm, 20 mm, and 4 mm from the central slice. (c) Sagittal slices, IS readout, LR position 36 mm, 30 mm, and 0 mm from the central slice. Maxillary right lateral incisor bracket was missing to allow the comparison.
